Sun Coast Marine
Surveying and Consulting

Marine Survey Report For SAMPLE SURVEY
"2004 Cruisers Yachts 405 Express"

18-336 2004 Cruisers Yachts 405 Express

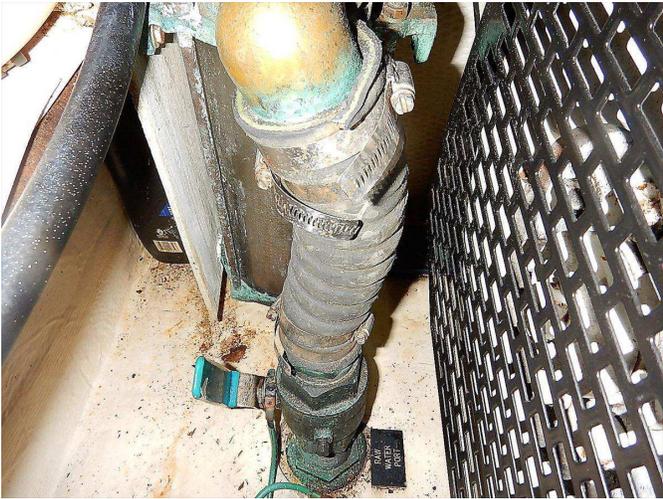
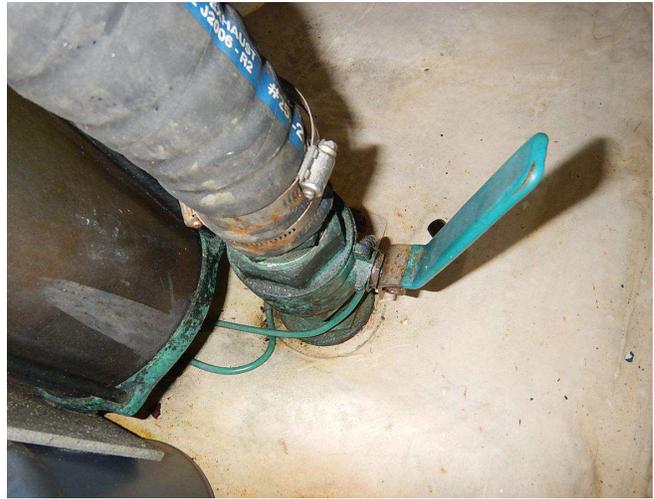
Corroded and broken hose clamps sighted on raw water intake hose on the port engine and other raw water intake sea valves.

RECOMMENDATION

Replace all hose clamps with corrosion on raw water intake valves and strainers.

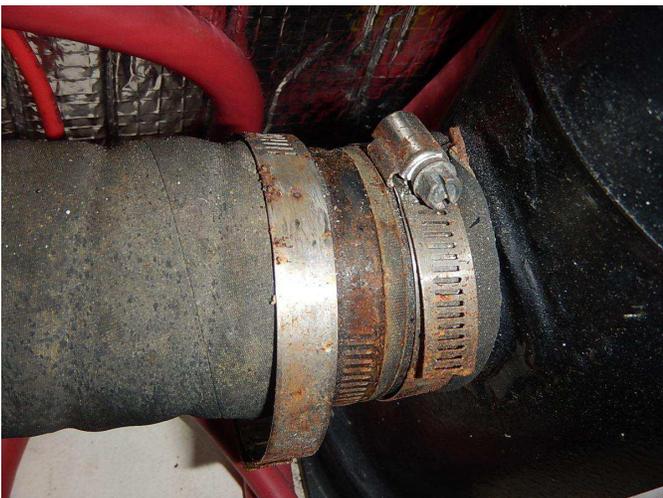
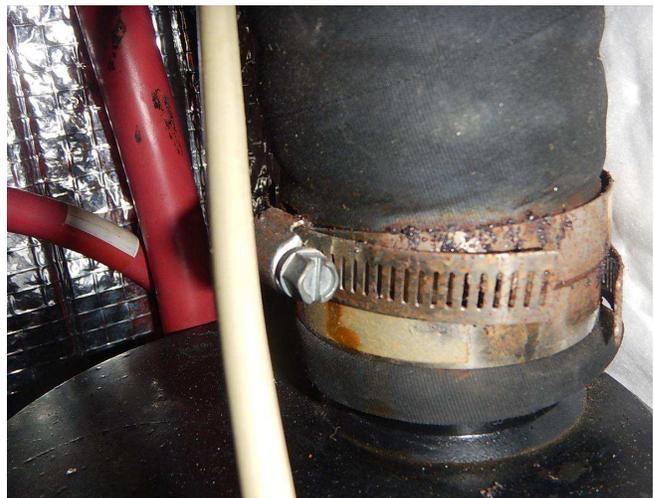
FINDING A-2 GENERATOR

The exhaust hose for the generator has a broken hose clamp and all show corrosion.

Replace hose clamps before use.

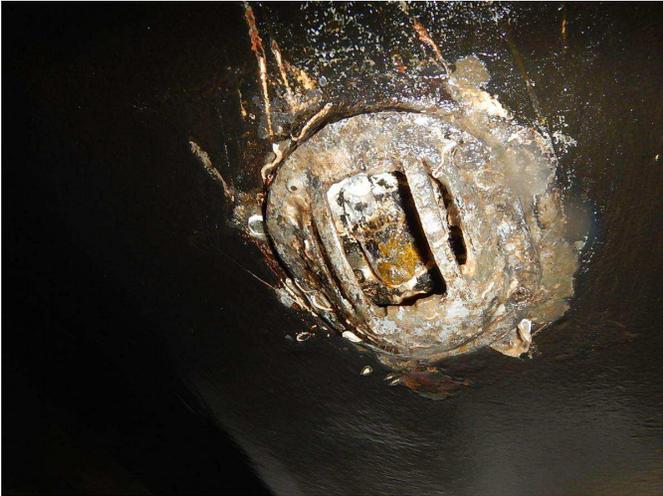
FINDING C-4 HELM STATION

The Raymarine ST60 Tri-data unit did not read speed.

Replace the speed wheel if log speed is desired.
