Sun Coast Marine
Surveying and Consulting

Marine Survey Report For SAMPLE SURVEY
"2004 Cruisers Yachts 405 Express"

18-336 2004 Cruisers Yachts 405 Express

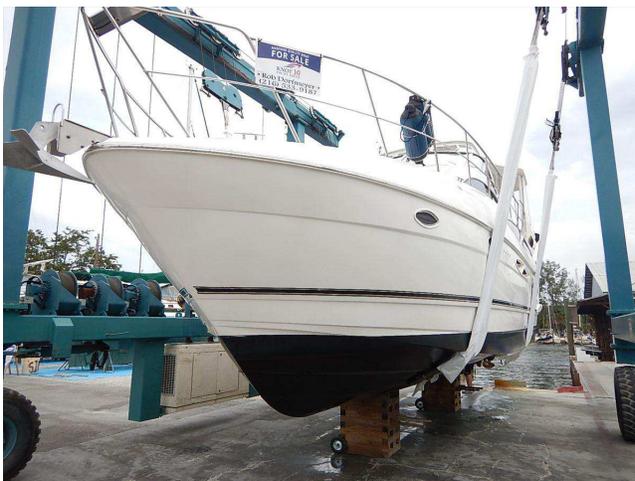
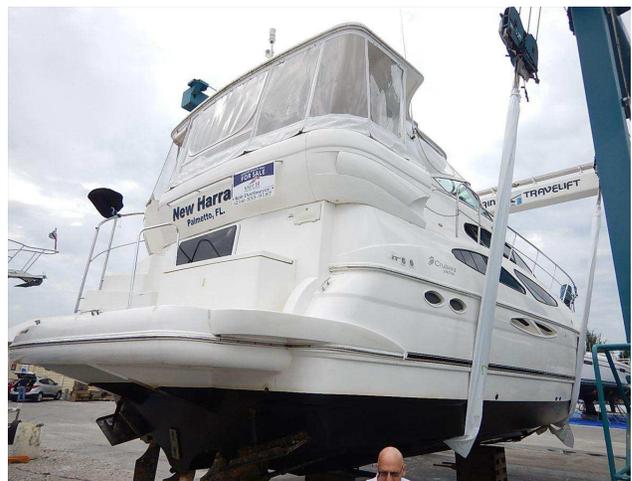
Well secured, no cracks or defects sighted. Moisture readings were relatively Dry. No delamination when checked with a percussion hammer.

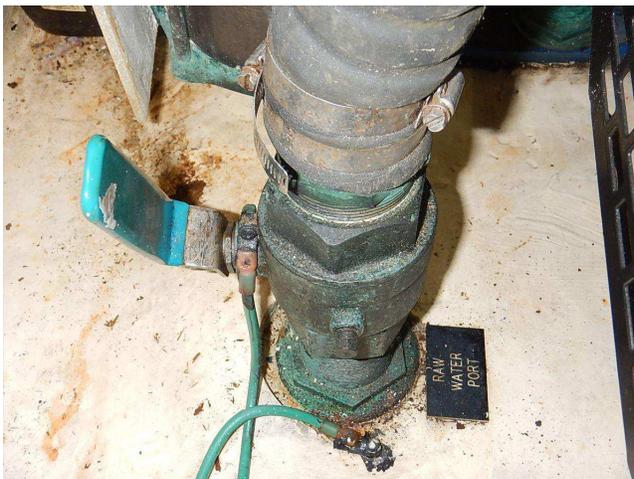
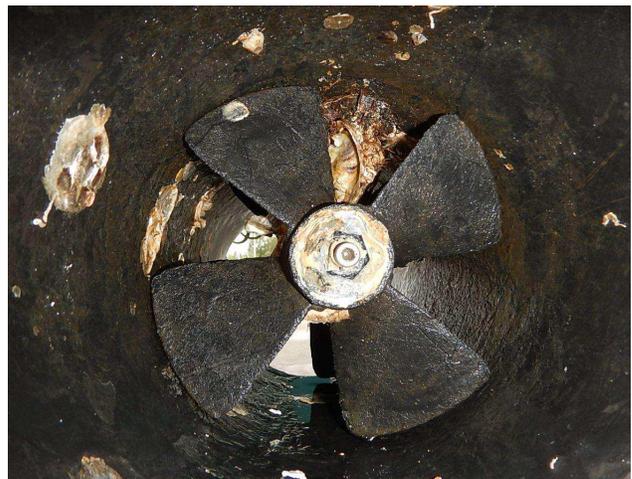
In apparent serviceable condition except as noted in the Findings & Recommendations.

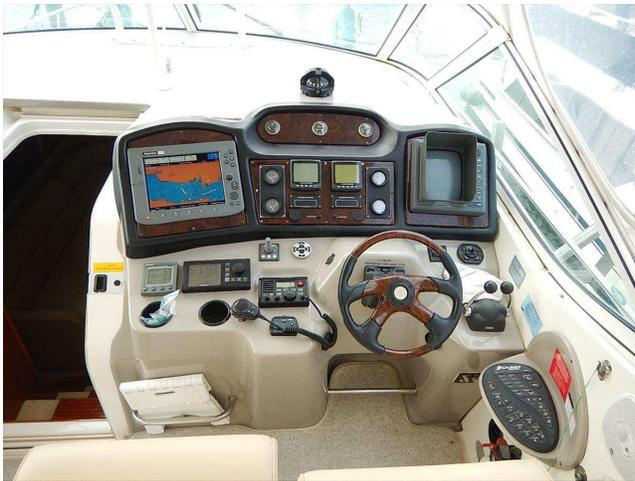
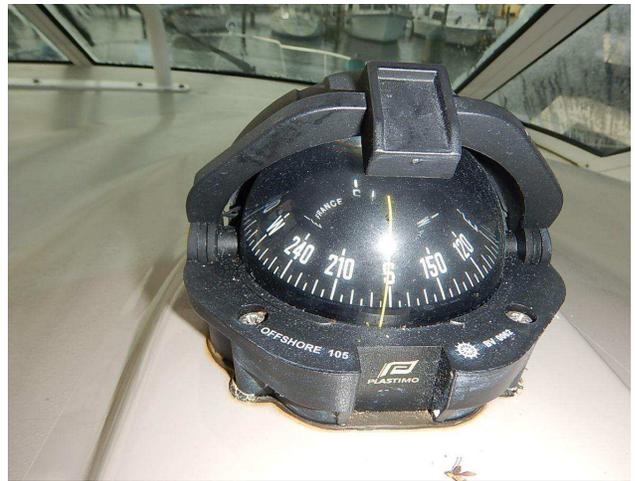
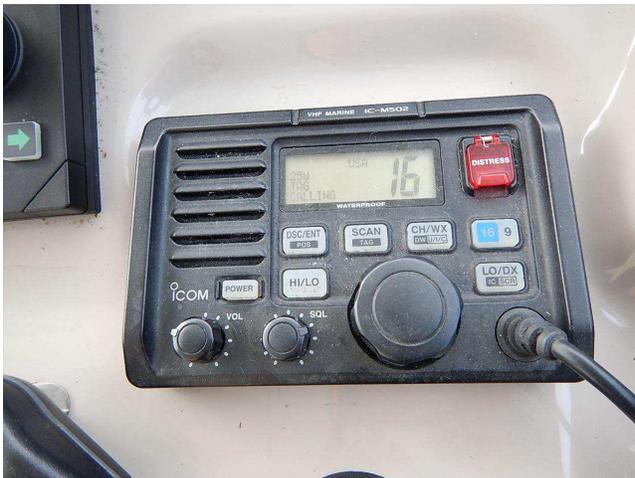
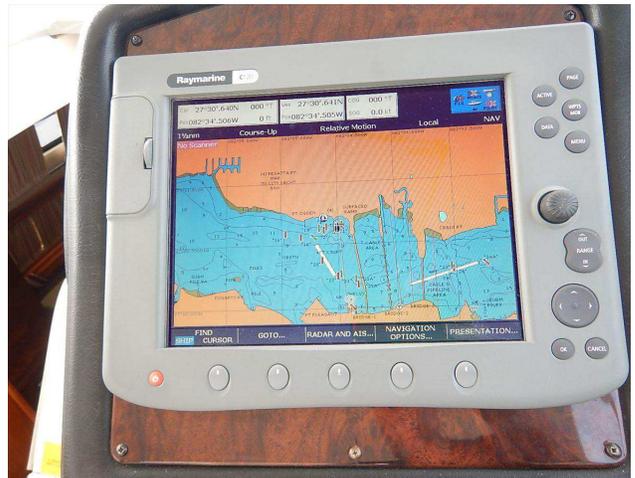
Electronics mounted on cockpit bulkhead. A 5" Plastimo compass in serviceable condition. The accuracy of the compass was not verified. An ICOM IC-M502 VHF radio, powered up and received transmission using the weather service. Unable to receive transmission when tested using the Sea Tow automated service. A Raymarine C120 chart plotter with navigational charts and SIMRAD AP20 autohelm system that was proven during the sea trial and a Furuno radar screen that was tested and proven operational. A Raymarine ST60 TriData depth and speed gauge that was partially functional. See Findings & Recommendations.

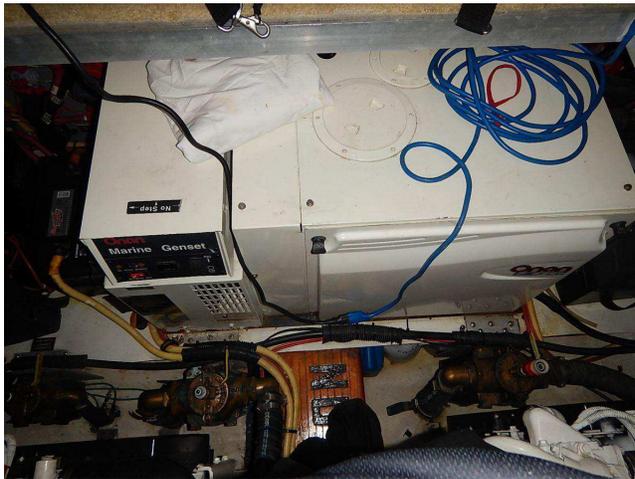
FINDING A-2

The exhaust hose for the generator has a broken hose clamp and all show corrosion.

Replace hose clamps before use.
